**Re: Duane & Lawrence, Sunnyvale – Addendum to January 31, 2006 Arborist Report**

## TREE SURVEY & ARBORIST REPORT

**Duane & Lawrence  
Sunnyvale, California**

**JANUARY 31, 2006 (revised from 12/15/05 Arborist Report, & 12/20/05 addendum)**

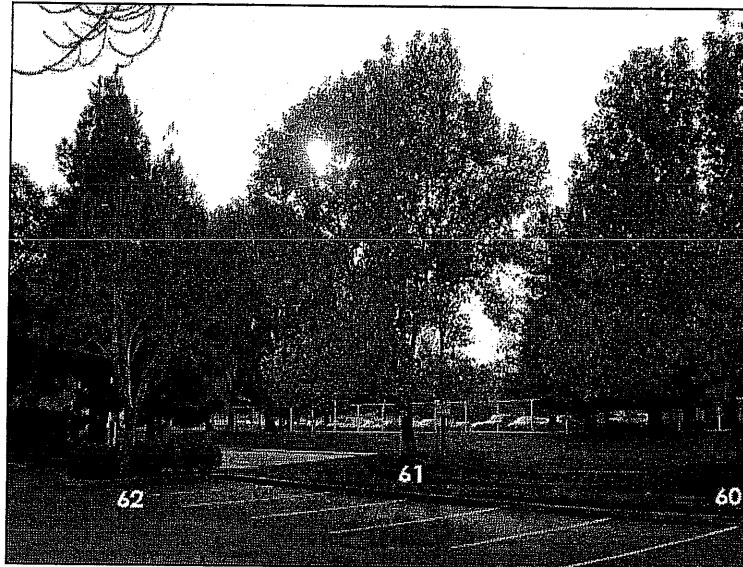
Cover photo: American sweet gum trees **#60 & 61** with their beautiful fall leaf color, and Norway maple **#62**. Taken from the east in the West parking lot of Stewart Avenue.

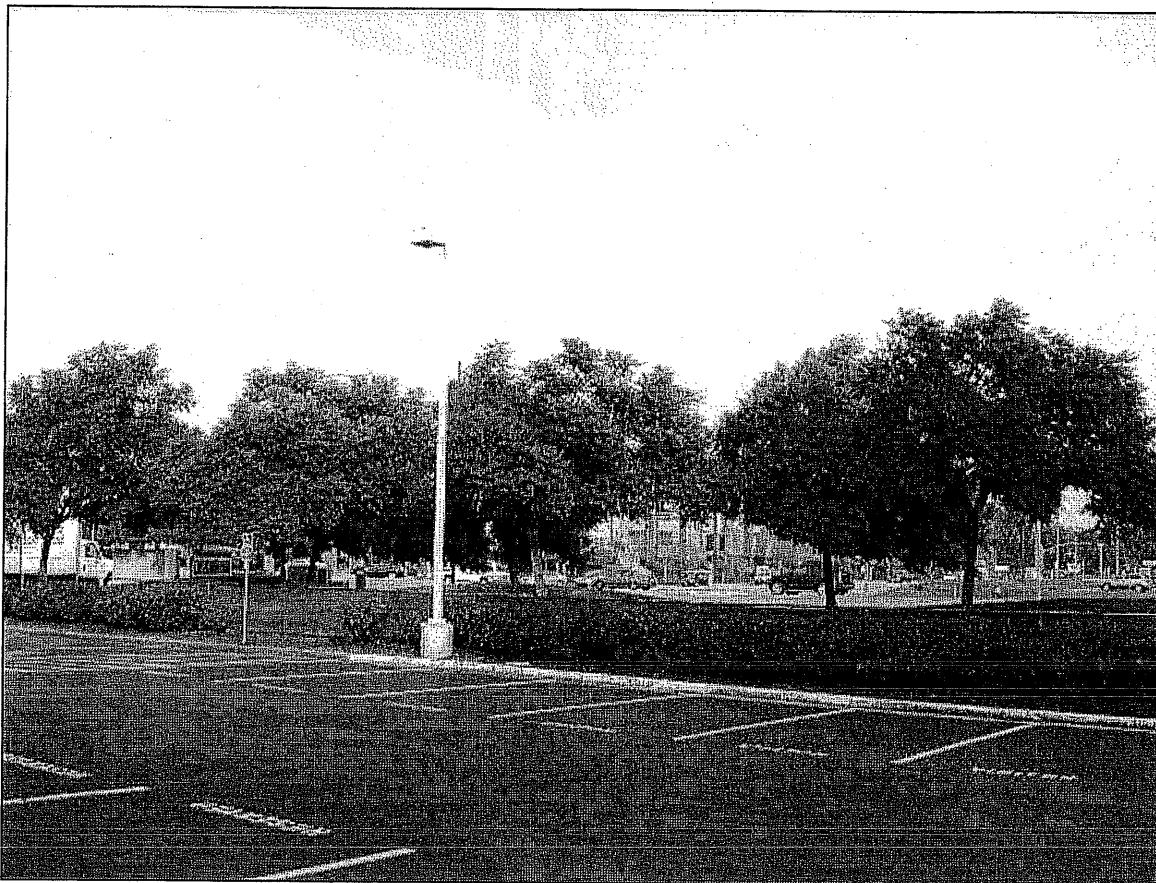
Jacaranda trees #3 through 9 along Lawrence Expressway, viewed from the southwest.

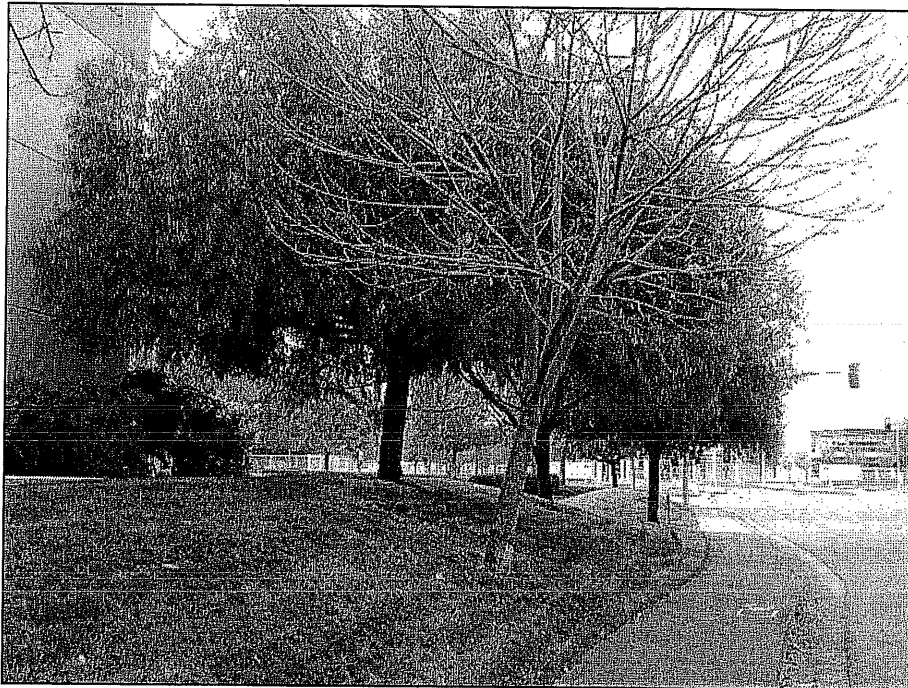
Ash & Australian willow trees along Duane Avenue, from the east.

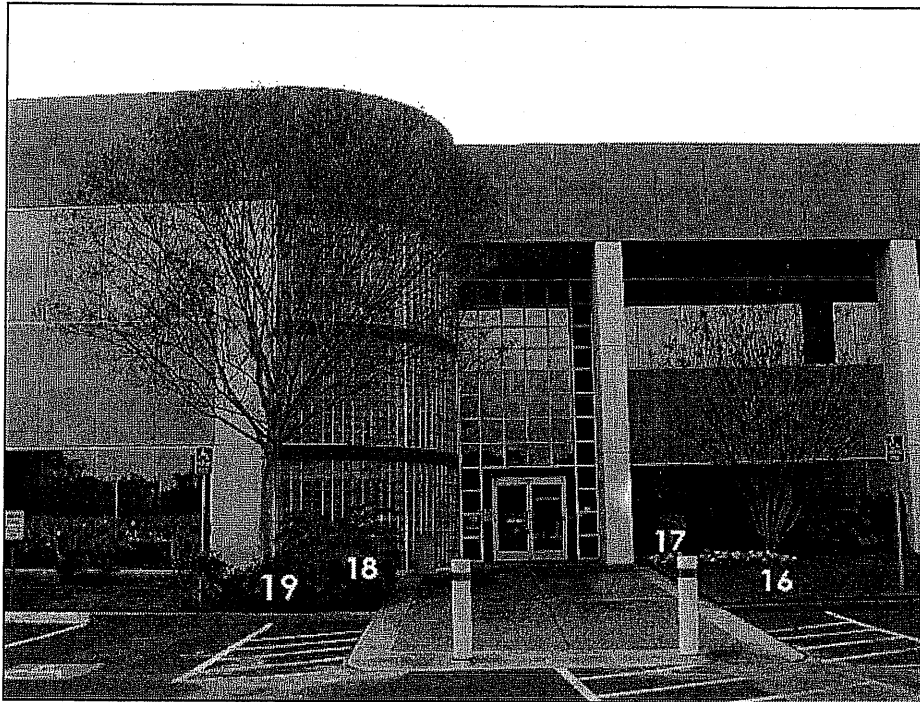
East side of existing building, viewed from Lawrence Expressway. Trees #16 & 19 are crape myrtles. Tree #17 is a small red-leaved Japanese maple. Tree #18 is a cycad, a primitive palm-like plant. This cycad is quite valuable due to its size.

#	Common name	DBH	Cond-V <sup>B</sup>	Cond-S	Work Needed (if tree remains)	Action	Notes
18	cycad	8.5	80	80		Transplant	Within proposed parking lot. Don't throw this away -- it is a very valuable plant! Recommend having it boxed and transplanted elsewhere.
19	crape myrtle	8.0	80	70		Remove	Within proposed parking lot. Could be transplanted or salvaged.
20	Japanese maple	10.9	80	60		Remove	Same as above
21	Australian willow	7.1	80	40		Remove	Poor condition -- tree deformed and severely bent over due to crowding by adjacent larger trees.
22	Australian willow	16.2	80	50		Remove	Tree a few feet away from proposed parking lot. Large scaffold branch failure & tear wound to N trunk. Looks like caused by multiple attachment of vertical scaffolds and branches with included bark.
23	Australian willow	5.6	70	40		Remove	Within proposed parking lot. Tree deformed and severely bent over due to crowding by adjacent larger trees.

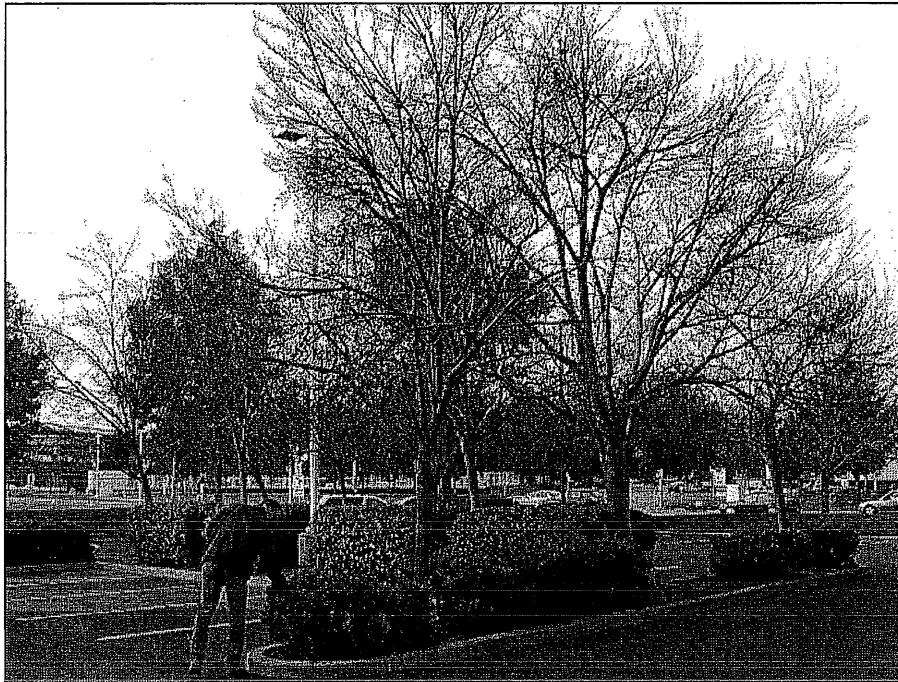
West parking lot along Stewart Drive. Trees within the parking lot are Raywood ash.

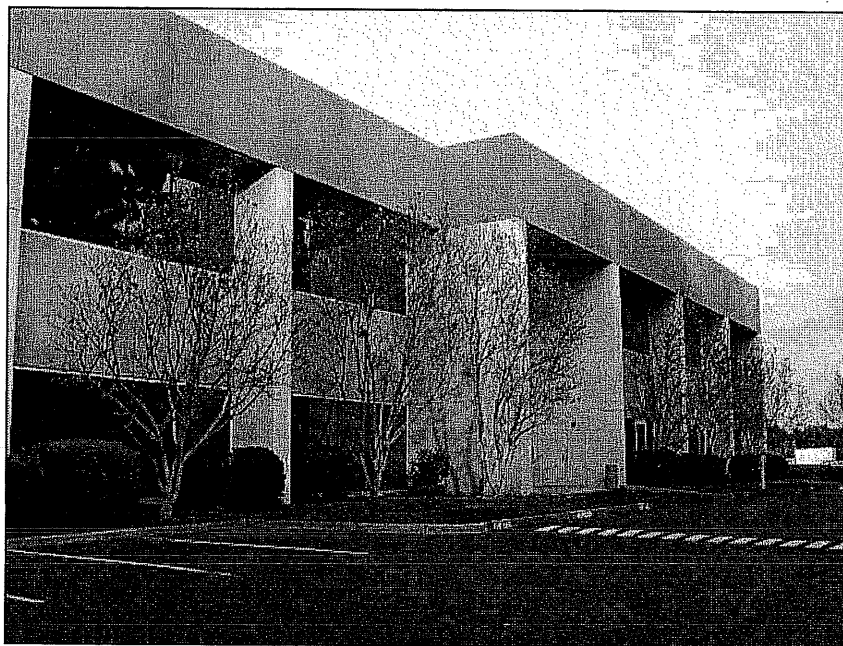
Saucer magnolias  
against south side of  
existing building.  
Trees #93 to 98,  
right to left.
